## In-situ, time resolved monitoring of uranium in BFS:OPC grout. Part 1: Corrosion in water vapour

Uranium encapsulated in grout was exposed to water vapour for extended periods of time. Through synchrotron x-ray powder diffraction and tomography measurements, uranium dioxide was determined the dominant corrosion product over a 50-week time period. The oxide growth rate initiated rapidly, with rates comparable to the  $U + H_2O$  reaction. Over time, the reaction rate decreased and eventually plateaued to a rate similar to the  $U + H_2O + O_2$  reaction. This behaviour was not attributed to oxygen ingress, but instead the decreasing permeability of the grout, limiting oxidising species access to the metal surface.

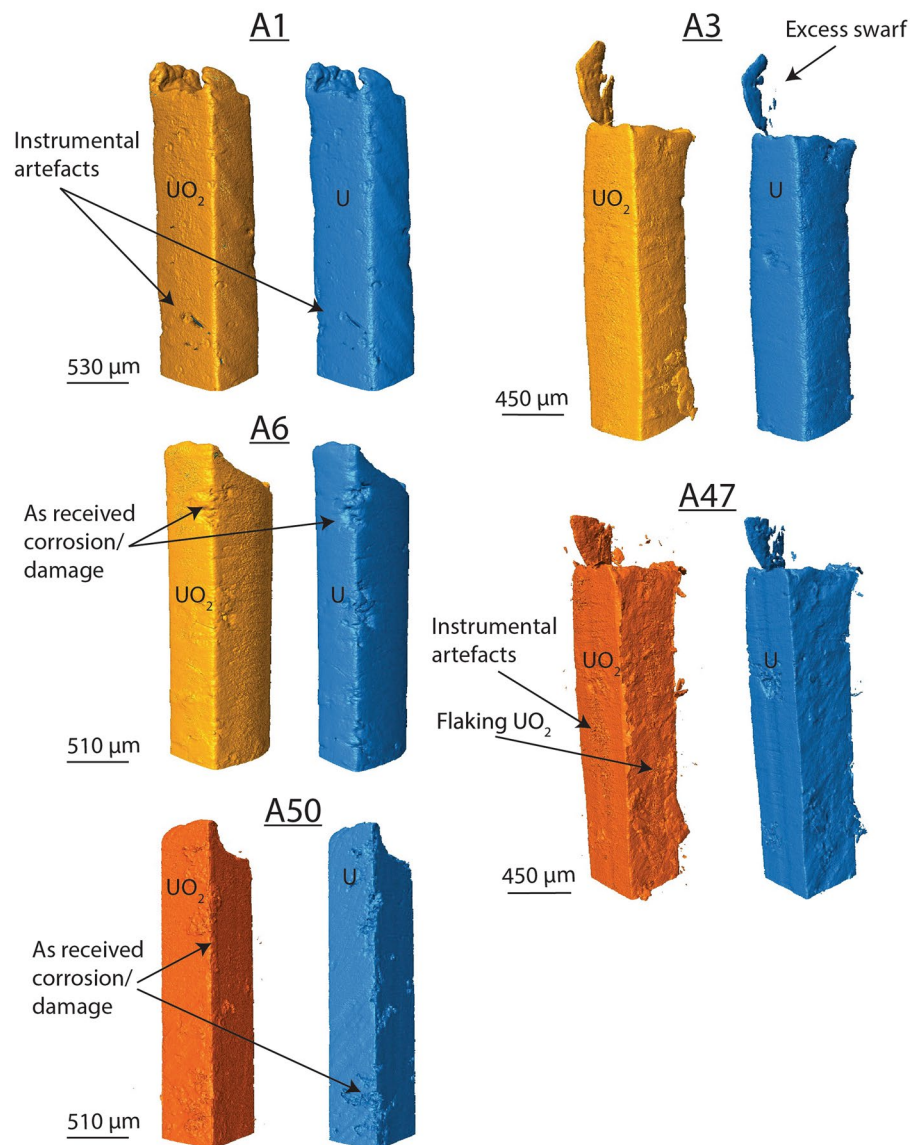
**Figure 2.** 3D renders of the as-received samples after exposure to water vapour. The contrast in density between uranium and  $\text{UO}_2$  permitted rendering of the two materials separately, thus the 3D renders of each sample are displayed in pairs. The images in blue show the residual uranium metal (right) and yellow or orange represents  $\text{UO}_2$  (left). The XRT quality between the two beam times changed dramatically and to show this, 3D renders in yellow are from using higher energies (115.6 keV) and orange from the lower energy (113.3 keV). Generally, edge artefacts, instrumental artefacts and absorption by the uranium prevented clean and sharp 3D renders for the higher energy beam time.

XRT images of each sample are displayed in Figs 2 and 3. As we expected from uranium characterisation before grout encapsulation (see Supplementary Fig. S1) the 'as-received' samples (Fig. 2) displayed a rough surface, with large areas of irregular sized pitting ( $\leq 250\text{ }\mu\text{m}$  diameter) which were filled with a corrosion product  $\leq 40\text{ }\mu\text{m}$  thick. The pitted areas were localised, with flat and uniform areas between. Only  $\text{UO}_2$  was detected by XRPD, however previous SIMS analysis also indicated carbon contamination (see Supplementary Fig. S2).

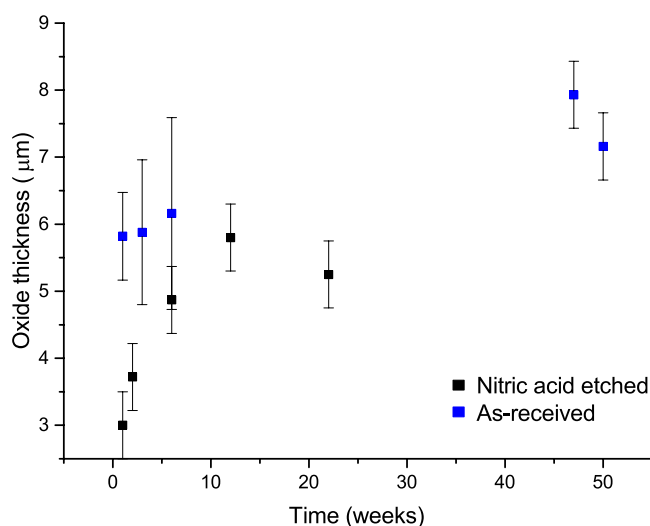
**Figure 4.** A plot demonstrating the change in  $\text{UO}_2$  thickness on each uranium sample when exposed to water vapour over time. Values and errors are extracted from Table 2.

Overall, we observed limited visual change between grout encapsulated uranium samples exposed to water vapour over progressively longer periods of time. We used cross sections at multiple positions of each sample render to measure the oxide thickness at 80 locations, and the average oxide thickness, with an associated error and range are shown in Table 2. In general, the oxide thickness of the uranium samples was observed to increase over time. More specifically, over the first 12 weeks the nitric acid etched uranium oxide growth appeared to initially grow rapidly, but then the growth rate decreased by 22 weeks (Fig. 4). Oxide thicknesses were greater and displayed a greater range on the 'as-received' samples owing to the initial corrosion layer present prior to encapsulation in grout.

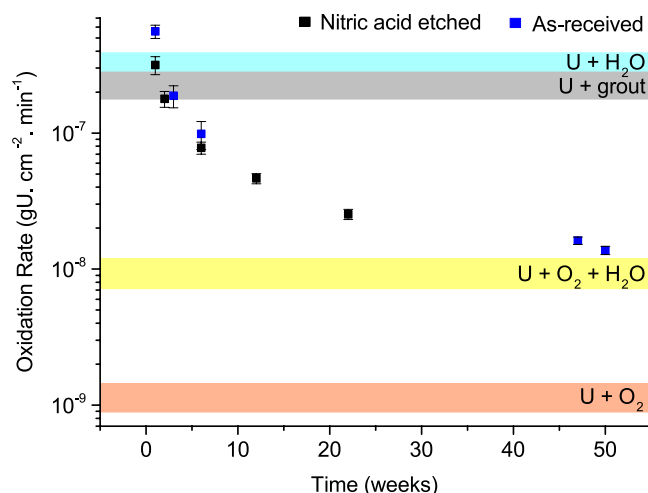
**Figure 5.** A plot demonstrating the variability in oxide growth rates of grout encapsulated uranium exposed to water vapour over time. Each band of colour represents the oxidation rate at 25 °C calculated from the empirically derived equations displayed at the beginning of this section by<sup>12, 13, 30, 36</sup>. These rates are compared to the rates calculated from the oxide thicknesses determined here. The error bars originate from the errors exhibited in Table 2, which have been processed through the equations.

To indicate the predominant mechanism for corrosion in the grouted system, we compared the rates of oxidation observed here to the empirically derived linear rates from the literature, in Fig. 5. The derived Arrhenius rate expressions used were:

Figure 5 shows that the oxidation of grout encapsulated uranium, which had been exposed to water vapour for increasingly longer time periods, initially proceeded at rates similar to those observed for the rapid  $U + H_2O$  oxidation regime reported by Delegard and Schmidt (6). However, over time the oxidation rates gradually decreased towards an apparent  $U + O_2 + H_2O$  regime, with a decay rate (D) of  $(3.96 \times 10^{-7})T^{-0.86}$ , where  $T$  = time (weeks) (Fig. 5). It is believed that this behaviour was directly related to the ageing properties of the grout.

Toward 50 weeks, the uranium oxidation rates change again and are observed to plateau (Fig. 5). This may suggest the beginning of a linear rate which is governed by the established permeability of a near fully matured grout, achieving a steady state which allows some slow diffusion of water vapour to the metal surface.
